**Performance Audit Report on the
Construction of the Ambalangoda
Fisheries Harbour and the
Improvement of the Living
Conditions of the Fishermen
through the Supply of Basic
Facilities of the Harbour**

Performance and Environmental Audit Unit

Report No. YS/PA/CFHC/2010

Auditor General' s Department

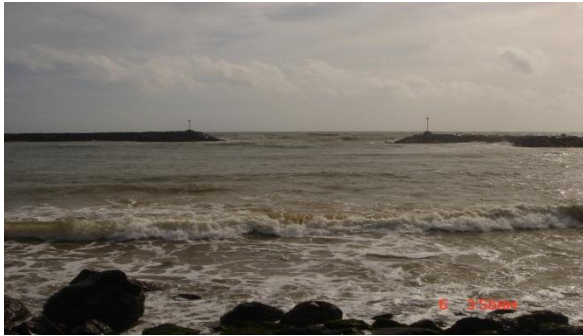
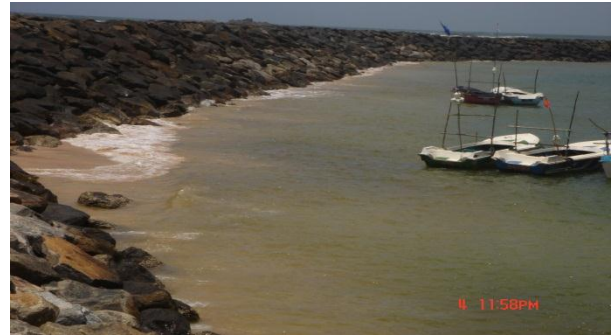
- iii. The Harbour Mouth had been designed and constructed facing the path of sea waves. Collision of boats in the basin as well as colliding against the jetty and sand deposits in the basin had resulted due to the waves reaching the basin continuously.

Waves reaching the Harbour Basin Continuously

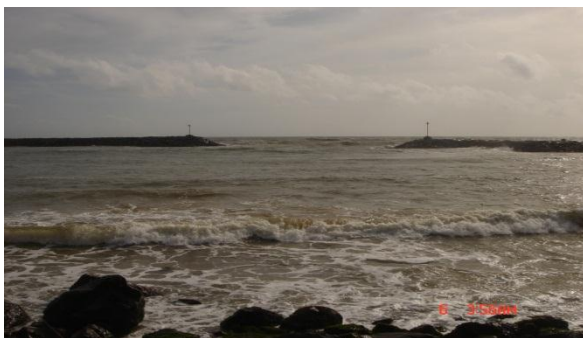
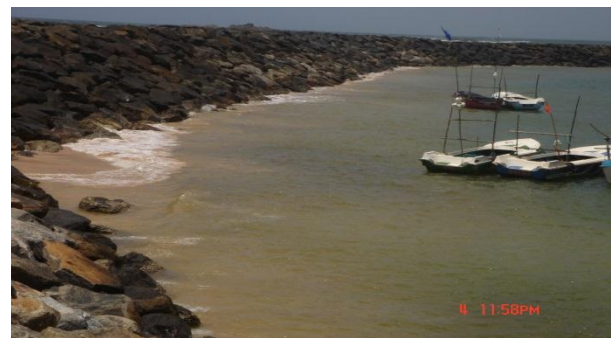
Waves reaching the Harbour Basin Continuously

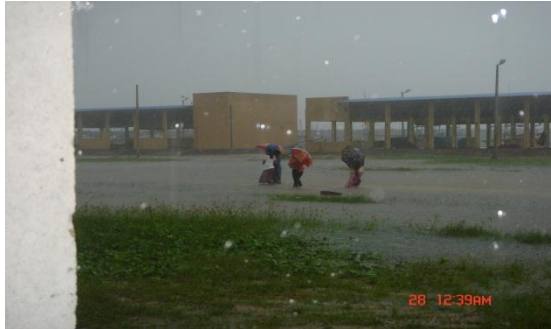
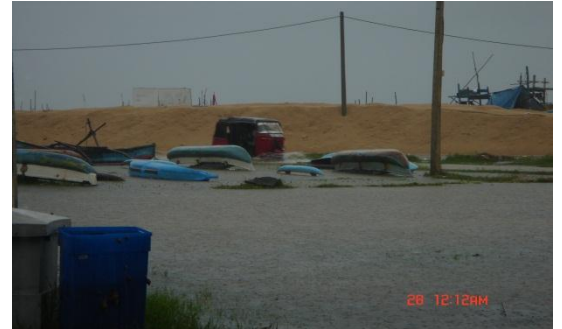
- vii. Difficulties had arisen due to the failure to construct a drains system for drainage of water collected during rainy season.

Harbour premises inundated with rain water during the Rainy Season

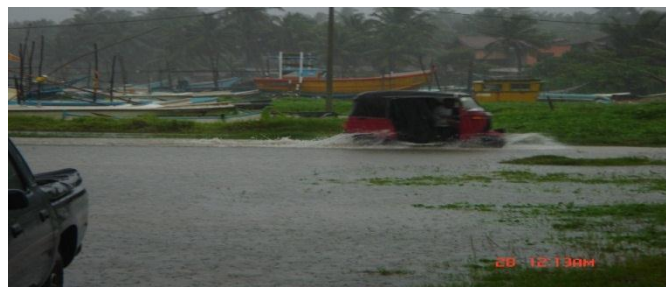
Harbour premises inundated with rain water during the Rainy Season

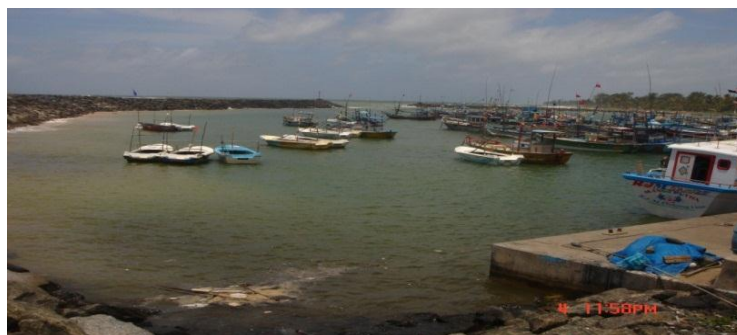
According to the Feasibility Study Report on the construction of the Harbour, plans had been made for anchoring 397 vessels in the Harbour Basin. Nevertheless, the anchorage facilities in the constructed Harbour is limited to 40 multiday fisheries vessels. The reduction of the estimates prepared at the initial designing of the Harbour had resulted in limiting an objectives at the commencement itself is a significant observation. In addition to the main reason for the limitation of space in the Harbour, the regular flow of sand into the Harbour had prevented the maximum use of the limited space available.

Vessels anchored in the limited space in the Harbour Basin

Action should be taken to examine the reasons for accumulation of sand deposits and take remedial action. The accumulated sand deposits should be removed regularly to ensure the maximum use of the Harbour Basin.

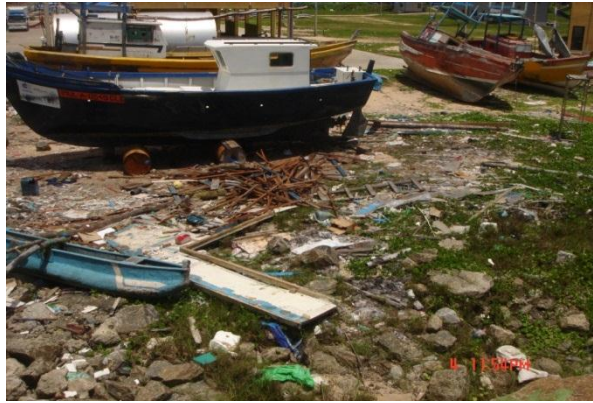
- v. The Harbour Basin being polluted due to the discharge of waste from the drains system of the town direct into the Harbour Basin. As the fishermen use such water for cleaning the fish, it had become a threat to the quality of the fish harvested.

polluted Harbour Premises
