Performance of using Techniques to achieve the Objectives of the Department of Meteorology

Report No. PER/A/WF/2018/03

National Audit Office Performance Audit Division

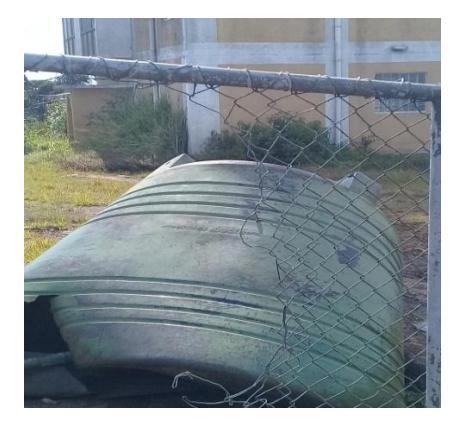
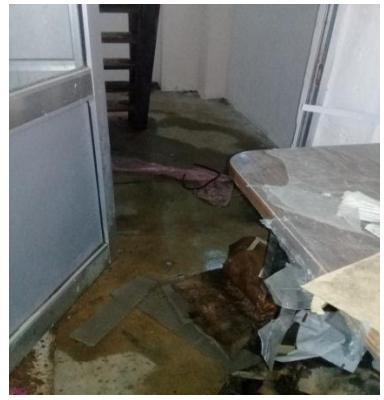
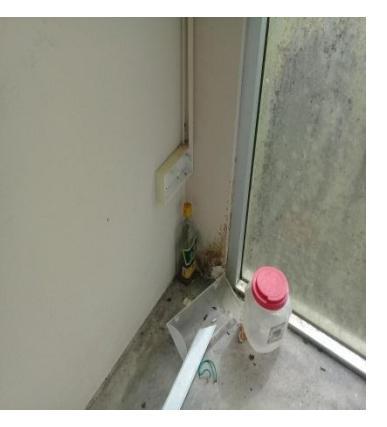
- i. The section of access road to the work site with a distance of 1km and 1 ¹/₂km was in very poor condition and there were several places that can be dangerous when traveling by vehicle.
- **ii.** New construction of an another institution next to the site.
- iii. Cutting of the covering fence for easy access to any person.
- iv. All the doors of the building were opened and the generator which was remained unsafe has decayed to the point that it cannot be reused.
- **v.** Thieves had removed the fixtures of the Tower.
- vi. Rain leakage from place to place of the building.
- vii. Rusted staircase which was made of iron.
- viii. Dispersion of items in the equipment room and that room being wet.
- **ix.** Leaving bottles of liquor inside the rooms of the building.
- **x.** Windows and doors were being in a dilapidated condition.
- **xi.** Lack of water and electricity

Cutting of the covering fence for easy access to any person

Rain water leakage

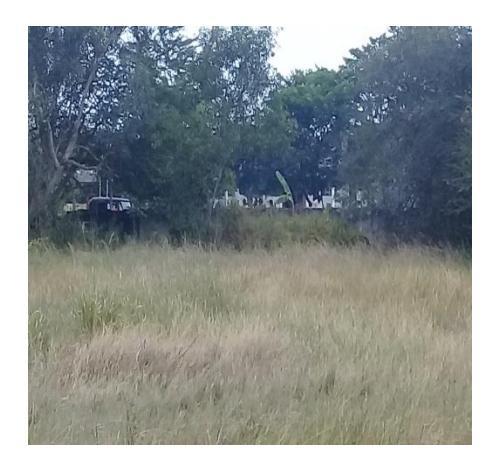
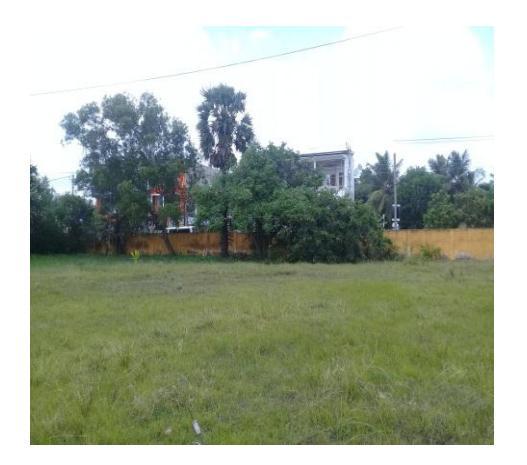
The Pottuvil site is located on the coastal line and these sensitive Equipment Parts can be highly corrosive. However, it was observed that attention had not been paid to this in the Report (Preparatory Survey) prepared by MIC Institution which is the main contractor of the Project. Both of these sites are plains and populated areas as well. There are schools, shops, private and government offices where the people are frequent near this area. It was observed that a school is located adjacent to the Puttalam site during the physical examination conducted by the audit on 19 June 2019. It was observed in the checking of the report prepared by the MIC Institution mentioned above, the attention had not been paid whether the radar emitted from this system would adversely affect the people there . Although it had stated in the letter of Central Environmental Authority that these Towers, which are nearly 42 meters high can cause lightning damage to nearby homes and buildings, as per the letter issued by the Director General of Meteorology NO.EB/CC/25 dated 18 December 2019 it had stated that no such environmental impact would be occurred.

Located schools, shops, private and government offices which are frequented by the public.

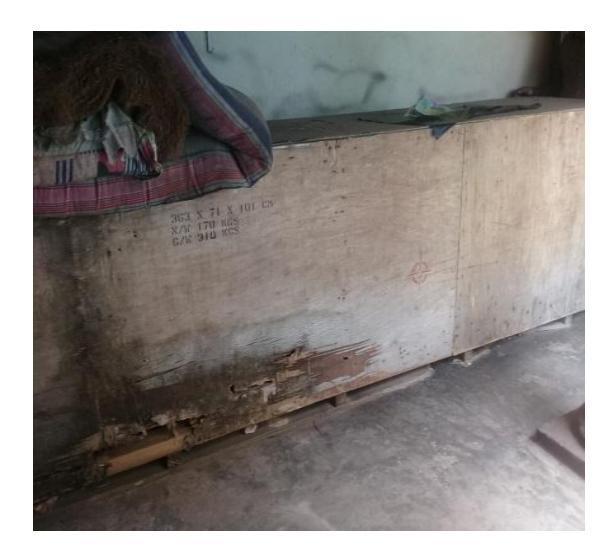
It was observed that the equipment which was supposed to be installed in Trincomalee by the Department of Meteorology had not been installed even by the date of audit 09 January 2019. Accordingly, the Department of Meteorology has not efficiently and effectively worked was observed towards achieving the objectives expected to obtain through the relevant grant .

The way of Storage of Mounting Pole of the AWS System to be installed at the Trincomalee Meteorological Center

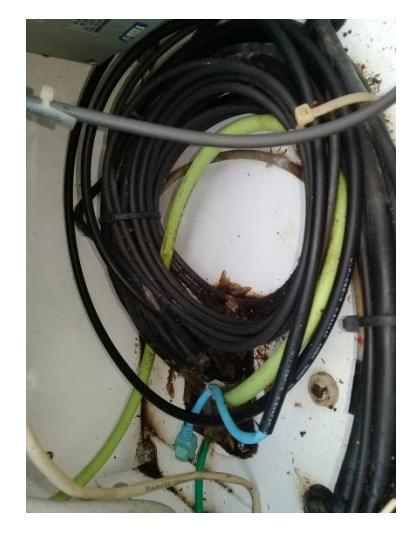
The way of remains of the insects around the AWS Data Logger located at Galle Meteorological Station (2019.03.06)

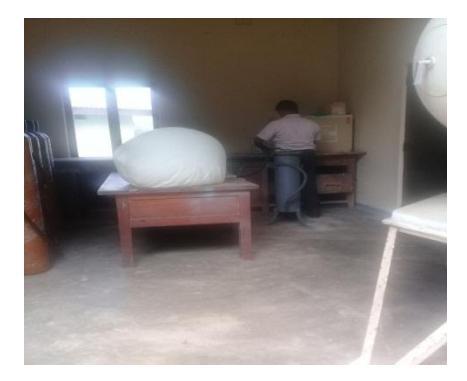
- i. Establishment of Hydrogen Production Plant adjacent to buildings where the frequent of public.
- ii. Not taking safety measures at the Hydrogen Plant.
- **iii.** Lack of protective clothing for the officers during the production of Hydrogen and sending of the balloon.

Unsafe filling of the Balloon

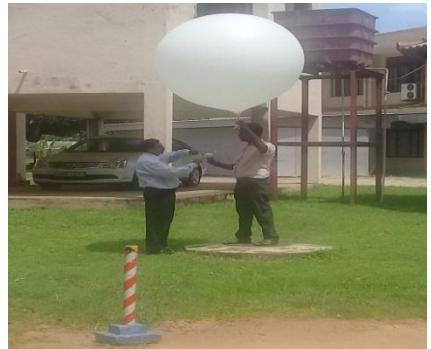
Unsafe sending of the Balloon

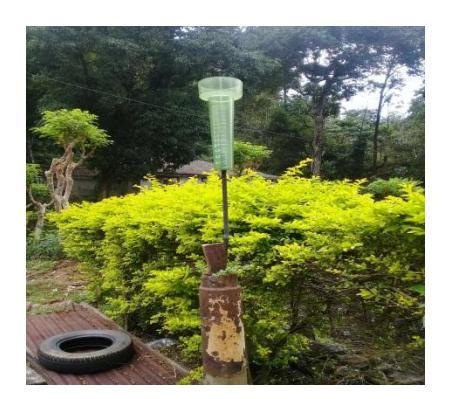
Aninkanda Tea Factory

Rainfall data should be taken in accordance with the World Meteorological Standards. However, it was observed at the physical examinations carried out by the audit that, these Rain Gauges were not in compliance to the relevant standards at the examination of the Rain Gauges located at Aninkanda and Tea Shakthi Tea Factory.
