Economic, Social and Environmental Impact Caused by the construction of the Port of Oluvil

1. Executive Summary

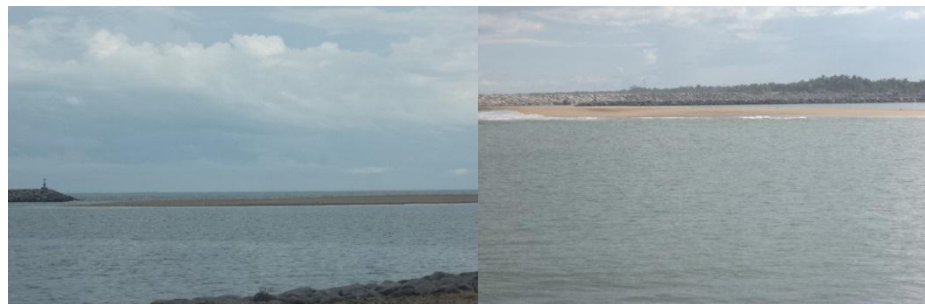
The breakwater constructed determined the port limits and controls the waves reaching the port. In addition, according to the situation of the sea coast of the east, the impact from sand is considerable. Even though the breakwater was constructed as a shield against that impact, in view of the nature of the situation of the Oluvil Port, the Consultants of the Project had reported in November 2013, that is, after the construction, on the impact of sand carried by the sea waves. That report included, among other matters, the erosion of the northern coast of the port, the accumulation of sand from the sea around the Southern Breakwater and the accumulation of sand and silt at the entrance to the Port and the basin. Heavy sand accumulation of sand was observed during the field inspection. At present, this obstruction has rendered the Port totally unusable for operations.

(Sand accumulation from the sea around Southern Breakwater -2015.12.09)

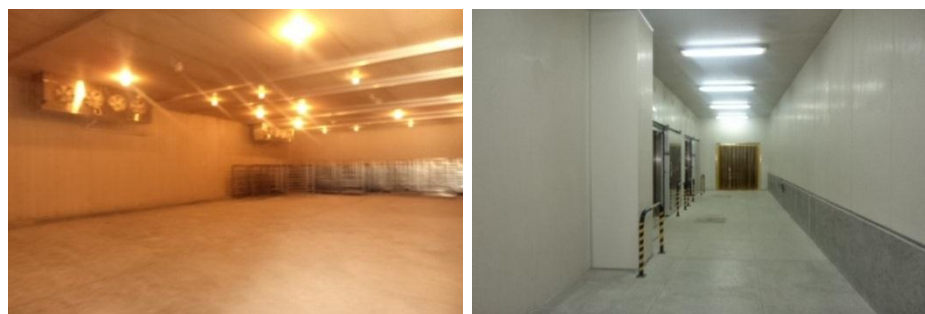
- i. A cold storage facility with the cold stores, a flaked ice Production Unit and fish processing facilities had been constructed. It was observed that the full capacity of 20 metric tons is not made use of.

(Unuses Cold Storage Premises – 2015.12.09)

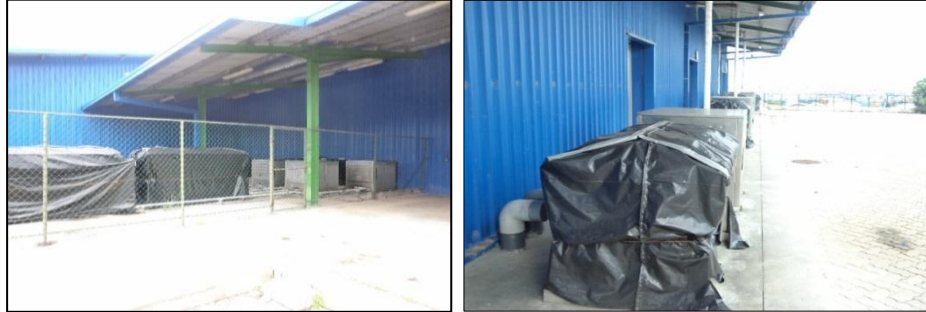
- ii. The highly valuable items of machinery available among the Cold Storage Facility are subject to the threat of destruction due to the non-utilisation. Even though the electricity generators and other machinery installed outside had been covered against rain as a temporary measure, it was observed that the covering did not provide protection from the wind blowing from the sea.

(Cover provided against rain for the electricity generators and other machinery -2015.12.09)

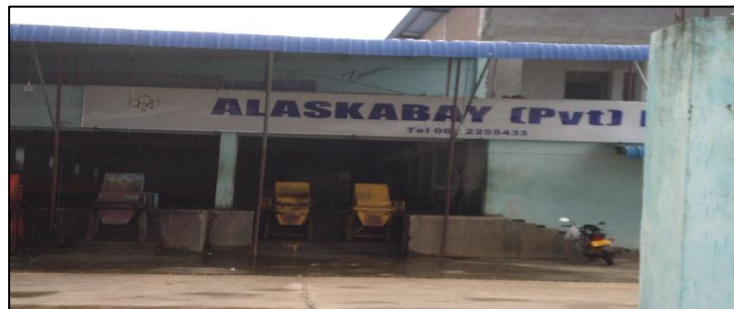
- iii. Other businessmen had established several production machines close to the Port. The price of ice produced by those machines was comparatively low. According to the opinion of the fisheries folk, despite such ice being of a standard below the required level, they are inclined to buy that ice due to the lower price. That reason itself had an impact on the idling of the Cold Storage Facility.

(Photograph of a Private Ice Production Facility -2015.12.09)

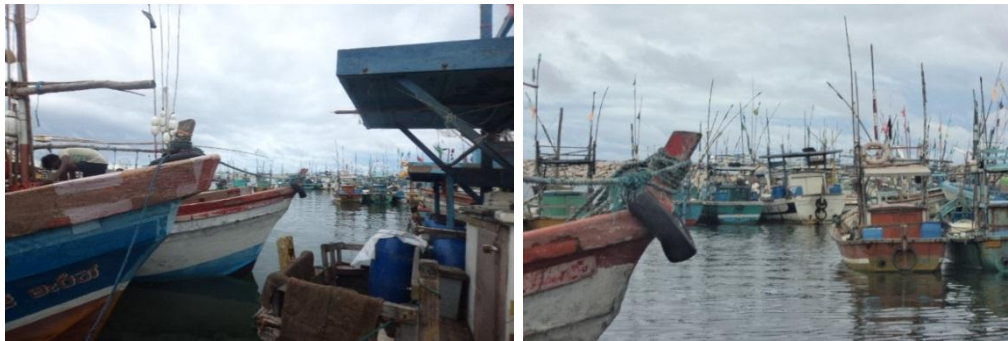
- v. It had been stated that the Port of Oluvil should be constructed as a remedy for the problems such as the sand accumulation of the Kirinda Fisheries Harbour, limitation of space available there for the fishermen of that area for safe anchorage of their boats, the lack of depth of the Harbour and the lack of repair facilities. But, it was observed that the Fishery Harbour constructed was of 03 metres depth and that it did not have the facilities for repair of fishing craft.

(Anchorage of Boats in the Fishery Harbour -2015.12.09)

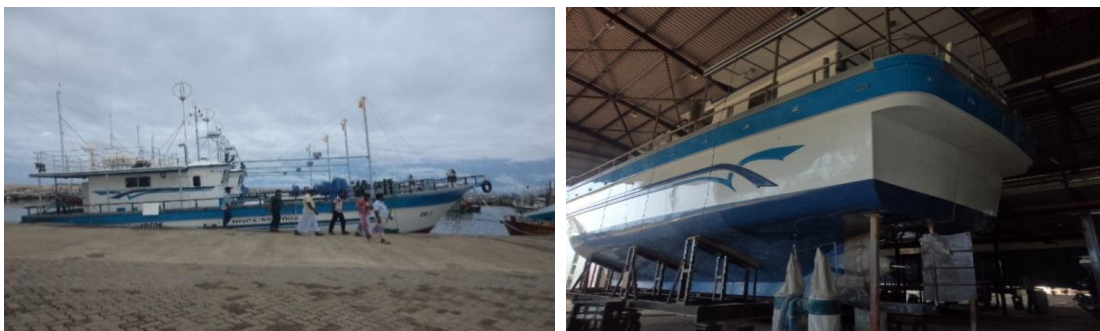
Even though the creation of employment opportunities for the people of the area was foremost as a general objective of all objectives of the Port Construction and providing opportunities for investments, it had not been achieved as intended. In response to the request for information in this connection, the Ports Authority informed that employees were not recruited for the new Port constructed, that the staff of the Nautical Training Institute of the Ports Authority situated nearby had been deployed for the purpose. Further, one private investor had commenced a medium scale fisheries craft manufacturing institution and provided employment to 80 employees. This industry commenced in the year 2014 had constructed and exported about 10 fisheries craft by the year 2015.

(A photograph of the Private Boat Factory – 2015.12.10)

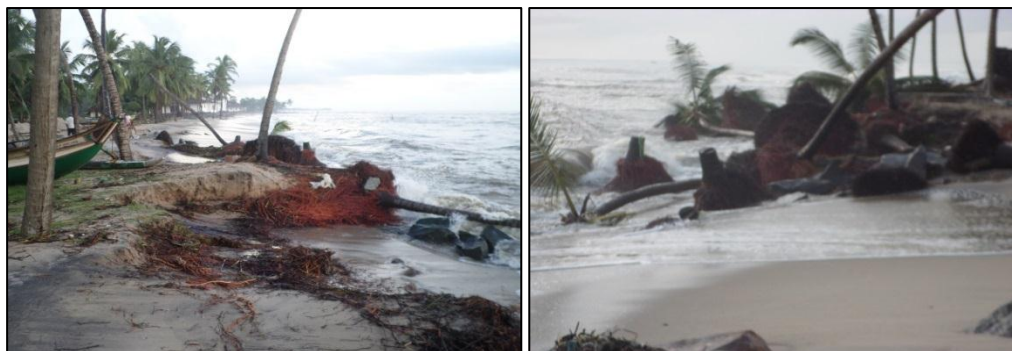
- i. The physical inspection revealed that subsequent to the construction of the Port, 5 kilometres approximately of the coastline north of the Port was subject to severe sea erosion. In view of this reason, the houses and properties, specially the coconut cultivations and the paddy lands of the people living in the littoral areas had been subjected to severe damage. Information on 33.74 acres of lands of coconut cultivation subjected to sea erosion was furnished to Audit by the Divisional Secretary Addalachchenai and the Agrarian Development Officer, Nindavur furnished information on 101 acres 53 roods and 70.5 perches of lands cultivated with coconuts and paddy covered by the sea coast.

(Impact of coastal erosion on Coconut Cultivation -2015.12.08)

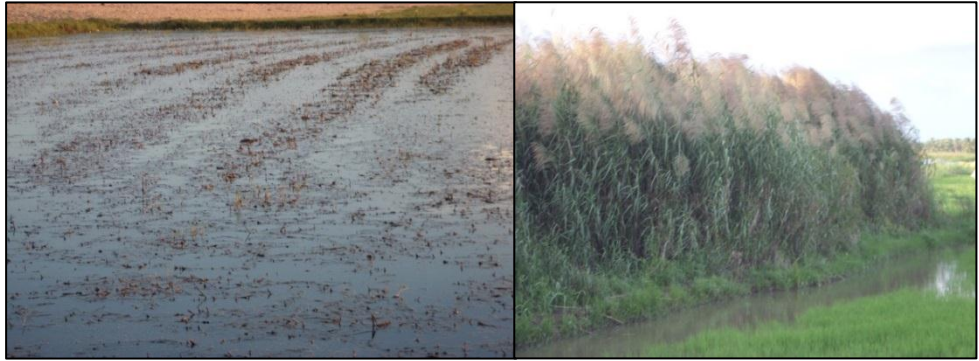
- ii. In addition, a large extent of paddy lands exist on the land north of the Port and in the past those paddy lands had been productively cultivated as stated to us by the land owners. Paddy for seed purposes had been commercially cultivated in that area. Since the construction of the Port, the irrigation channel of the paddy lands had been blocked and the sea water had flown into the paddy lands through the river, thus resulting in the paddy lands eroded into the sea while sea water had flown direct into the other paddy lands making them fallowed. It was observed during the physical inspection that if an urgent solution is not found for this problem, the entire track of paddy lands would become lands unfit for paddy cultivation in the future.

(Impact of the coastal erosion on the Paddy Cultivation -2015.12.08)

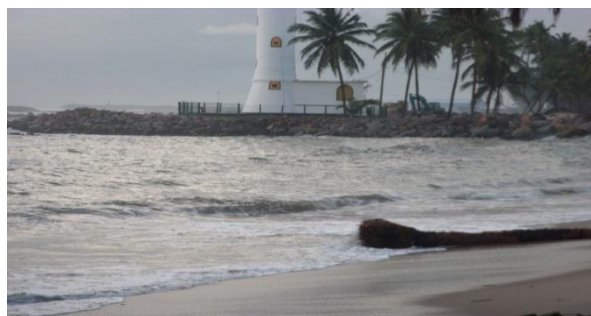
- iii. Even though the people of the Oluvil area had, over several years (since the commencement of the Port construction) made complaints about the sea erosion to the Department of Coast Conservation and Coastal Resource Management over a period of 07 years from June 2008 to the year 2015, the Department of Coast Conservation and Coastal Resource Management had failed taken any remedial action in connection with the problem. According to the information made available by the Department the bids invited after making plans for the protection of the Oluvil Lighthouse, for the purchase of construction materials and the required machinery on hire had been opened only on 10 September 2015. Subsequent physical audit inspection of the area around the Lighthouse revealed that the conservation action was in progress, whilst no attention had been paid to the conservation of the other areas subjected to erosion. The Zonal Engineers' office in charge of this coastal area is situated in Batticaloa. That office was established in the year 2010 and a Engineer had not been attached to the office even by 31 December 2015, the date of audit.

(Stone bunds erected for protection of the Lighthouse -2015.12.09)
